Case Study: Ohope Beach Rising Main Receiving Chamber

Region: Whakatane

Client/Contractor: Draintech

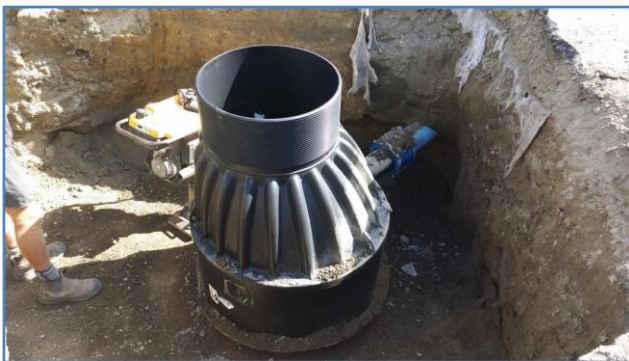
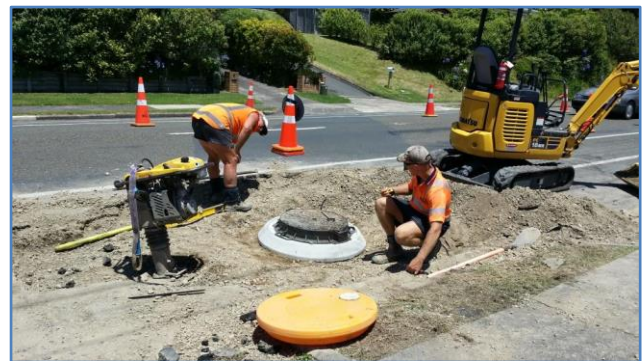
- An existing rising main receiving chamber of concrete construction had suffered from H₂S attack and required replacement.
- The ROMOLD DN1000 PP/PE manhole was chosen for its durability and resistance to corrosion.
- The application was within a busy roadway which experiences significant holiday traffic.

- A custom fabricated PE base was used to enable easy and fast connection to the existing rising main and two further lateral connections.
- Pre-planning of angles and invert levels of the inlets was essential and allowed the install to run smoothly.
- The pre-fabricated chamber base was installed within several hours allowing the line to go live without undue delay. As a result the reliance on sucker trucks to collect from the rising main was minimised.
- The complete chamber was installed ready for road sealing in 1½ days.
